Manhole Inspection Summary

Manhole # S250__014MH

Location Address: **1273 WASHINGTON BLVD.**

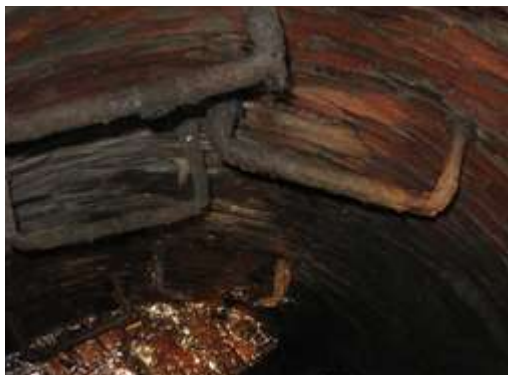
Defect 8

Count: **7** Missing: **2** ☒ Corroded

CORRODED STEPS WITH 2 MISSING

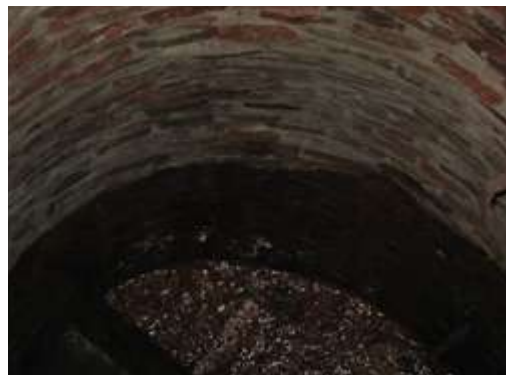
Defect 7

☒ Evidence Of Surcharge Depth: **5** (ft.) ☐ Active Surcharge Present

EVIDENCE OF Surcharge

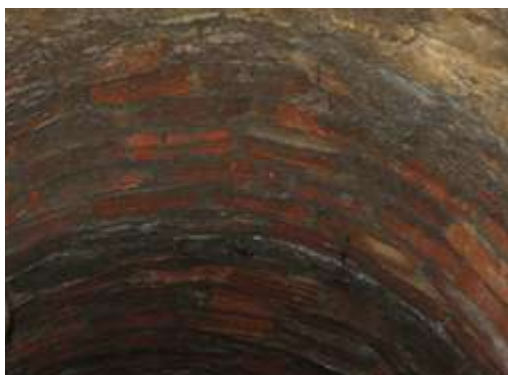
Defect 6

Infiltration: ☐ None ☐ Joint ☐ Cracks ☒ Mortar ☐ Roots ☒ Wall

EVIDENCE OF INFILTRATION AT
CHIMNEY AND CORBEL (MUD
DEPOSITS)

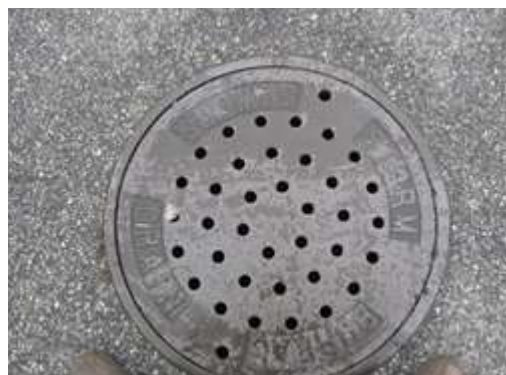
Defect 3

Comments **WRONG MANHOLE LID, STORM DRAIN LID ON A SEWER MH WITH INFILTRATION**

WRONG COVER (STORM DRAIN not
MH) SOURCE OF INFILTRATION -
Coded as Missing Cover

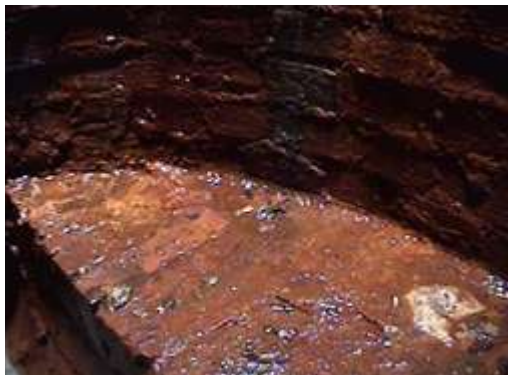
Defect 2

Infiltration: ☐ None ☐ Joint ☐ Cracks ☒ Mortar ☐ Roots ☒ Wall

ACTIVE BARREL INFILTRATION

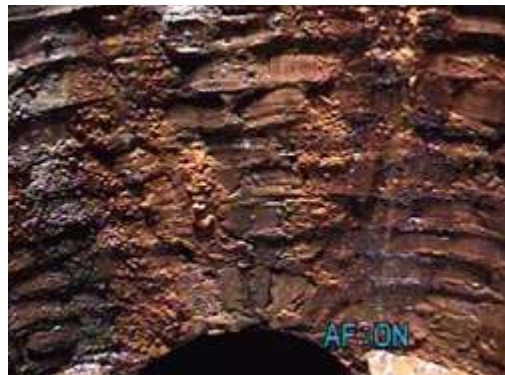
Defect 1

Condition: ☐ Sound ☐ Cracked ☐ Root Intrusion ☐ Loose Brick ☒ Deteriorated

DETERIORATED BARREL

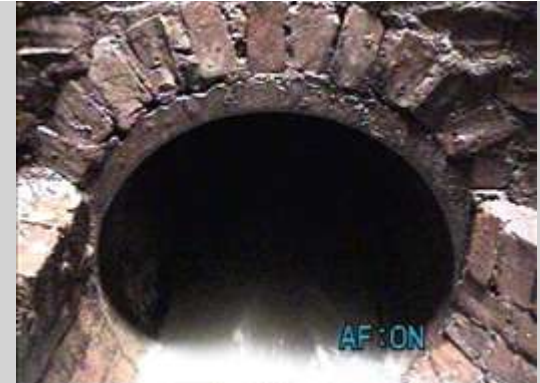
12 O'Clock Outflow

Pipe Height: **22.8** (in.) Rod and Bar (Angled)
Pipe Material: **Clay** ☐ Pipe Lined
Invert Depth: **14.40** (ft.) Flow Characteristics: **Turbulent**
Deposits: ☒ None ☐ Mud ☐ Sludge ☐ Debris ☐ Grease
Silt Depth: **0** (in.) Deposits Extent:
Infiltration: **Evidence** Pipe Seal Cond: **Unknown**

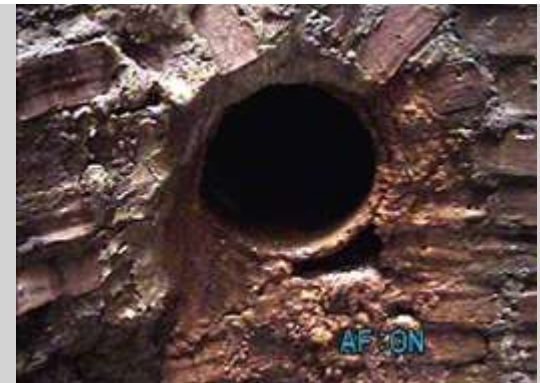
3 O'Clock Inflow

Pipe Height: **8.4** (in.) Rod and Bar (Angled)
Pipe Material: **Clay** ☐ Pipe Lined
Invert Depth: **10.50** (ft.) Flow Characteristics: **Fast**
Deposits: ☒ None ☐ Mud ☐ Sludge ☐ Debris ☐ Grease
Silt Depth: **0** (in.) Deposits Extent:
Infiltration: **Evidence** Pipe Seal Cond: **Unknown**

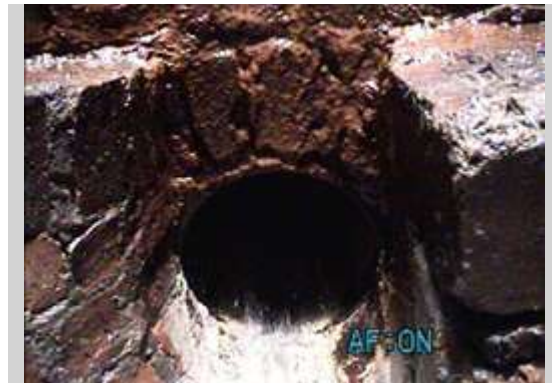
Drop In @ 3 O'Clock

Drop: **Outside** Rod and Bar
Angled: **Yes** Reading: **13.12** (ft.)
Inv Depth: **14.12** (ft.)
Drop Condition: **Open**

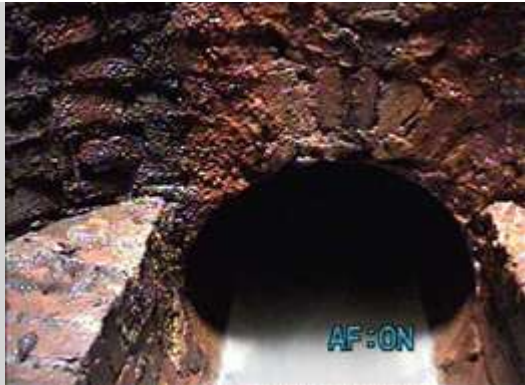
6 O'Clock Inflow

Infiltration: **Evidence** Pipe Seal Cond: **Unknown**
